PERFORMANCE OF RUBBLIZED PAVEMENT SECTIONS IN ALABAMA

Final Report

Highway Research Center

Auburn University

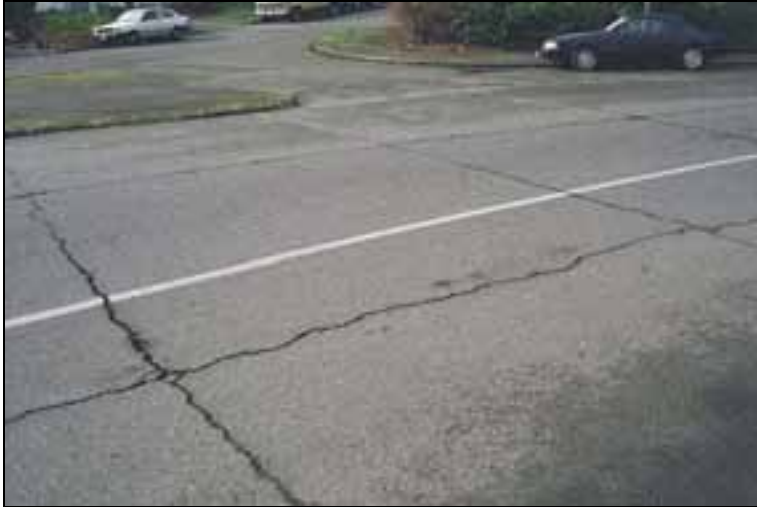
Figure 2.1 Reflective Cracking.

When rehabilitating PCC pavements, a common practice is to place an HMA overlay on top of the existing pavement structure (Freeman, 2002). However, a problem that has presented itself when utilizing an overlay is the development of reflective cracking through the depth of the newly placed overlay. This problem, known as joint reflective cracking, is a distress unique only to materials that have been laid over PCC pavements (Shahin, 1994). This type cracking is illustrated in Figure 2.1. The main concern with reflective cracking in HMA overlays is that reflective cracks accelerate the deterioration of the pavement structure. This deterioration is caused by water and incompressible solids filling the cracks that over time degrade the HMA (Yoder and Witczak, 1975).

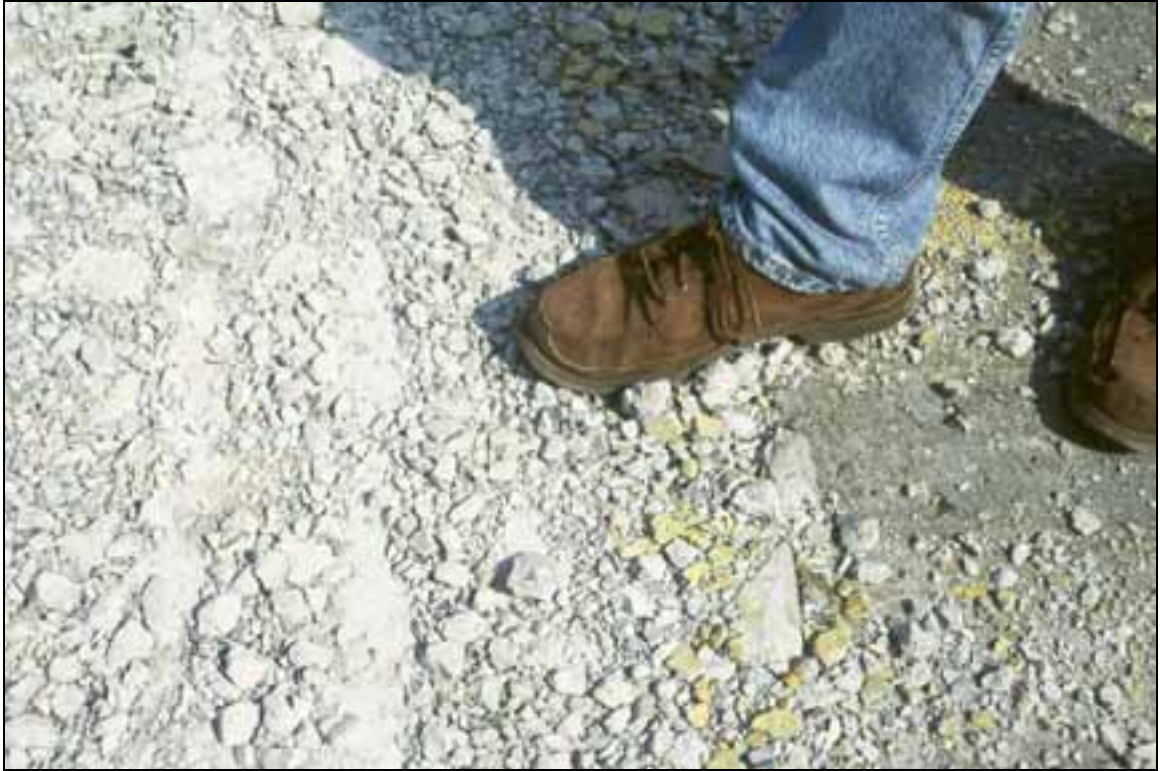
Figure 2.3 Rubblized Pavement.

Rubblization of PCC pavement is a rehabilitation technique that uses a form of the fractured slab process, which includes transforming the original concrete slab into an aggregate base. The objective is to break the PCC pavement without allowing the slab to expand excessively, damage the subgrade in any way, and still produce a rubblized PCC that is uniform in particle size and distribution (Kirk, 2001). The rubblization of a PCC pavement transforms existing concrete slabs and recycles it in place to form a high quality granular base as seen in Figure 2.3. This fractured slab technique, along with a properly designed edge drain system, has proven to be an effective means of rehabilitating PCC pavement (Ksaibati, 1998).

The new granular base is considered to be a high-strength base material because of the particle-shape properties that rubblized particles possess. These properties can be described as a puzzle (Kirk, 2001). The granular puzzle acts as a flexible system using aggregate interlock to transfer the applied loads to the subbase or subgrade.

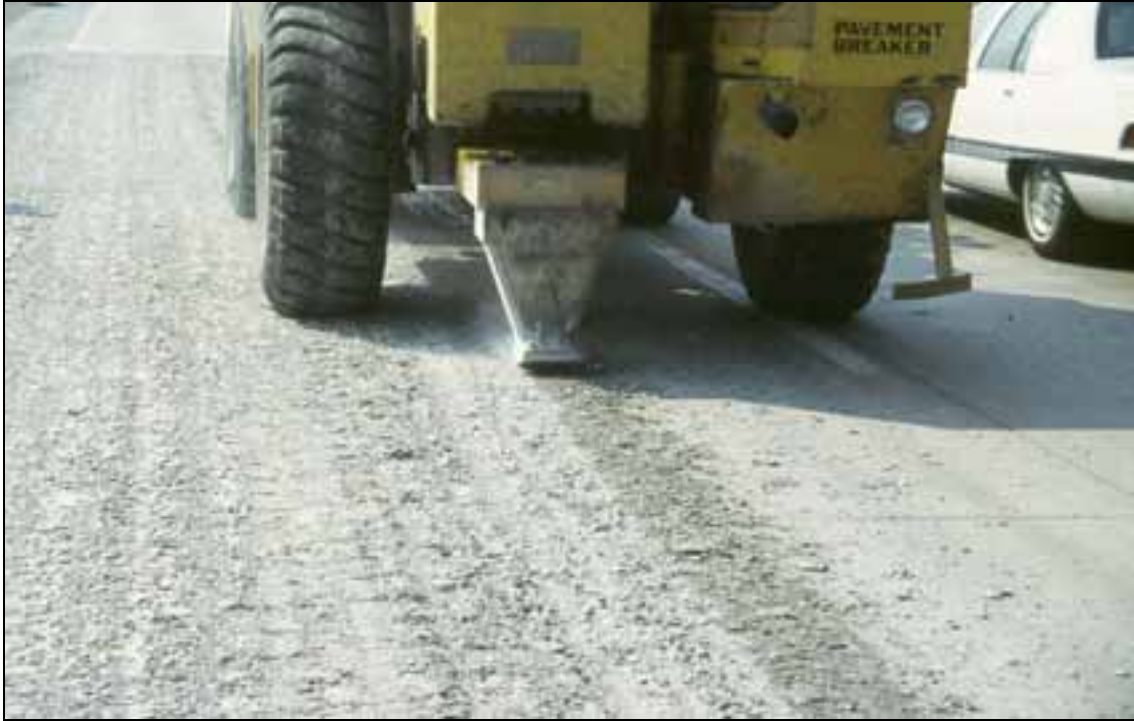
Figure 2.4 Resonance Frequency Breaker (Photo courtesy of Dr. Kevin Hall, University of Arkansas).

In 1986 John Brizzell, a New York Department of Transportation materials engineer, observed the resonance breaker and thought that it might eliminate reflective cracking. He recommended that the process be called rubblization (Kirk, 2001). The resonance frequency breaker uses a 15 cm (6 in) shoe located on the end of a pedestal that is connected to a beam with 5443 kg (12,000 lbs) counter weight located at the opposite end of the beam to break up the PCC pavement. This machine uses a low

amplitude (<12.5 mm) high frequency (44 Hz) shoe to deliver energy to the slab that is near the harmonic frequency of PCC. Figure 2.4 shows an illustration of the shoe that is used to rubblize PCC. This results in an area of high tension at the top of the PCC and causes the slab to fracture on a shear plane approximately 35 degrees from the pavement surface (Fitts, 2001).

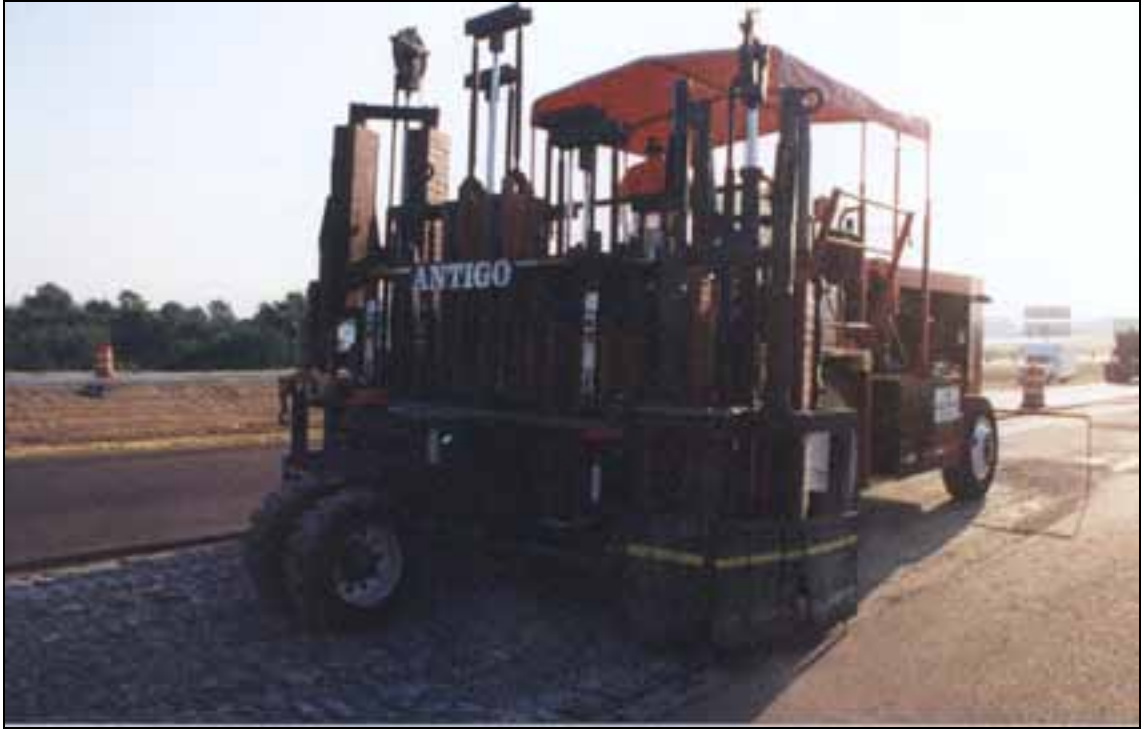
Figure 2.5 Multi-Head Breaker (photo courtesy of Dr. Kevin Hall, University of Arkansas).

The MHB (Figure 2.5) operates by dropping a series of twelve to sixteen 102 to 123 lbs. (454 to 545 N) hammers on the PCC slab generating between 2,000 ft-lbs and 12,000 ft-lbs. (2,700 and 16,000 J). This crushes the pavement into a granular base and is capable of pulverizing pavements widths ranging from 2 ft to 12.5 ft (.61 to 4.0 m) (Fitts, 2001). The MHB allows a one-pass rubblization process and eliminates the subgrade stability issues. The one pass approach of the MHB eliminates the shoving or punch through of fractured PCC pieces which damages the subgrade. It can effectively rubblize 0.75 to 1.0 lane-mile/day (1.2 to 1.7 lane-kilometers/day) (Thompson, 1997). It is interesting to note that although the MHB has a one-pass capability, the rate of rubblization per day is less than the rate of the resonance frequency breaker.

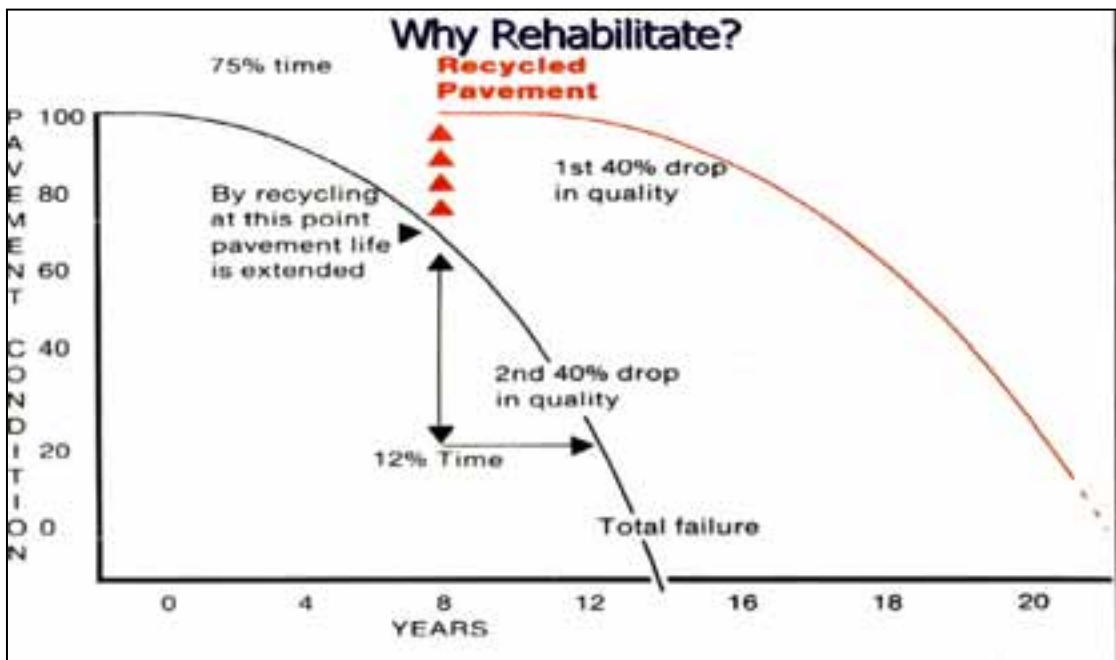
Figure 2.6 Benefits of Pavement Rehabilitation (Asphalt Recycling and Reclaiming Association, 1996).

With research to support the feasibility of the fractured slab procedures, another very important concern that all agencies face when dealing with pavement rehabilitation is the cost of construction. The World Bank (1996) conducted research on the feasibility of pavement system maintenance. They found that it will cost four to five times more if maintenance is delayed until the pavement loses 80% of its original quality than it would if maintenance was done during the first 40% drop in pavement quality (Figure 2.6). It is also important to notice the trend in which the pavement tends to deteriorate; with this downward exponential deterioration rate, not only does the rehabilitation save monetary resources, but also increases the projected life of the pavement tremendously.

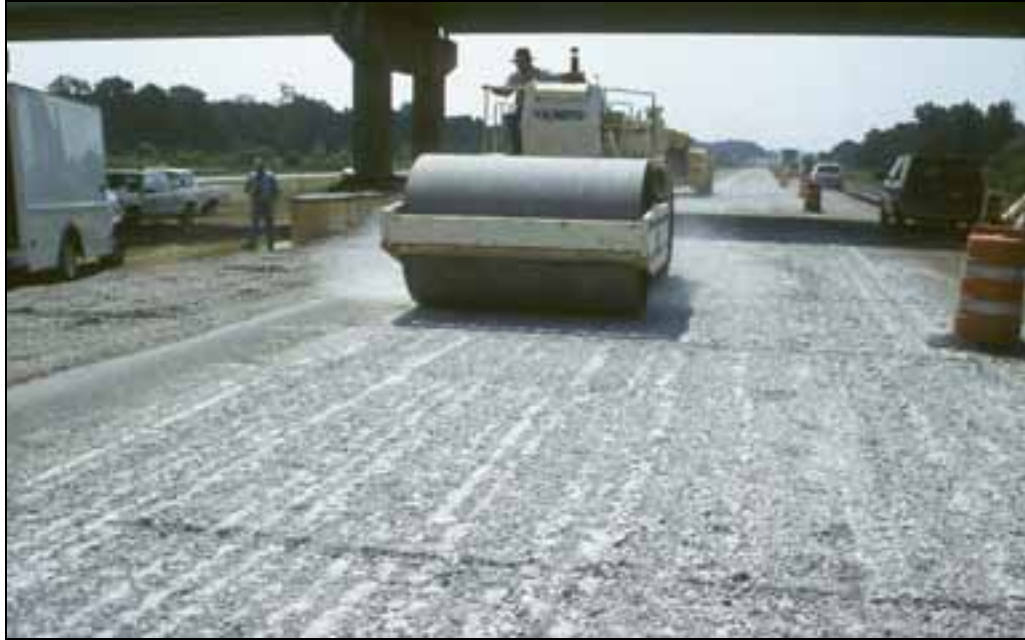
Figure 2.7 Seating the Pavement (photo by Kevin D. Hall, University of Arkansas).

Before the HMA can be placed, the proper seating of the rubblized material must be achieved. The compaction is obtained using no less than one pass of a vibratory steel wheel roller having a nominal gross weight of at least 20 tons (ALDOT, 2001). Figure 2.7 demonstrates the use of the steel roller to seat the rubblized pavement. In the next step of the compaction process, the steel wheel roller will be followed by at least one pass of a self-propelled pneumatic roller. The pneumatic roller should have a gross weight of at least 25 tons. This roller is to be followed by two additional passes of the steel wheel roller. When rubblizing reinforced concrete, the reinforcing steel is to be left in place, unless it is exposed at the surface. In the event the reinforcing steel is exposed during the rubblization or compaction process, it is to be cut below the surface and removed from the job site (ALDOT, 2001).

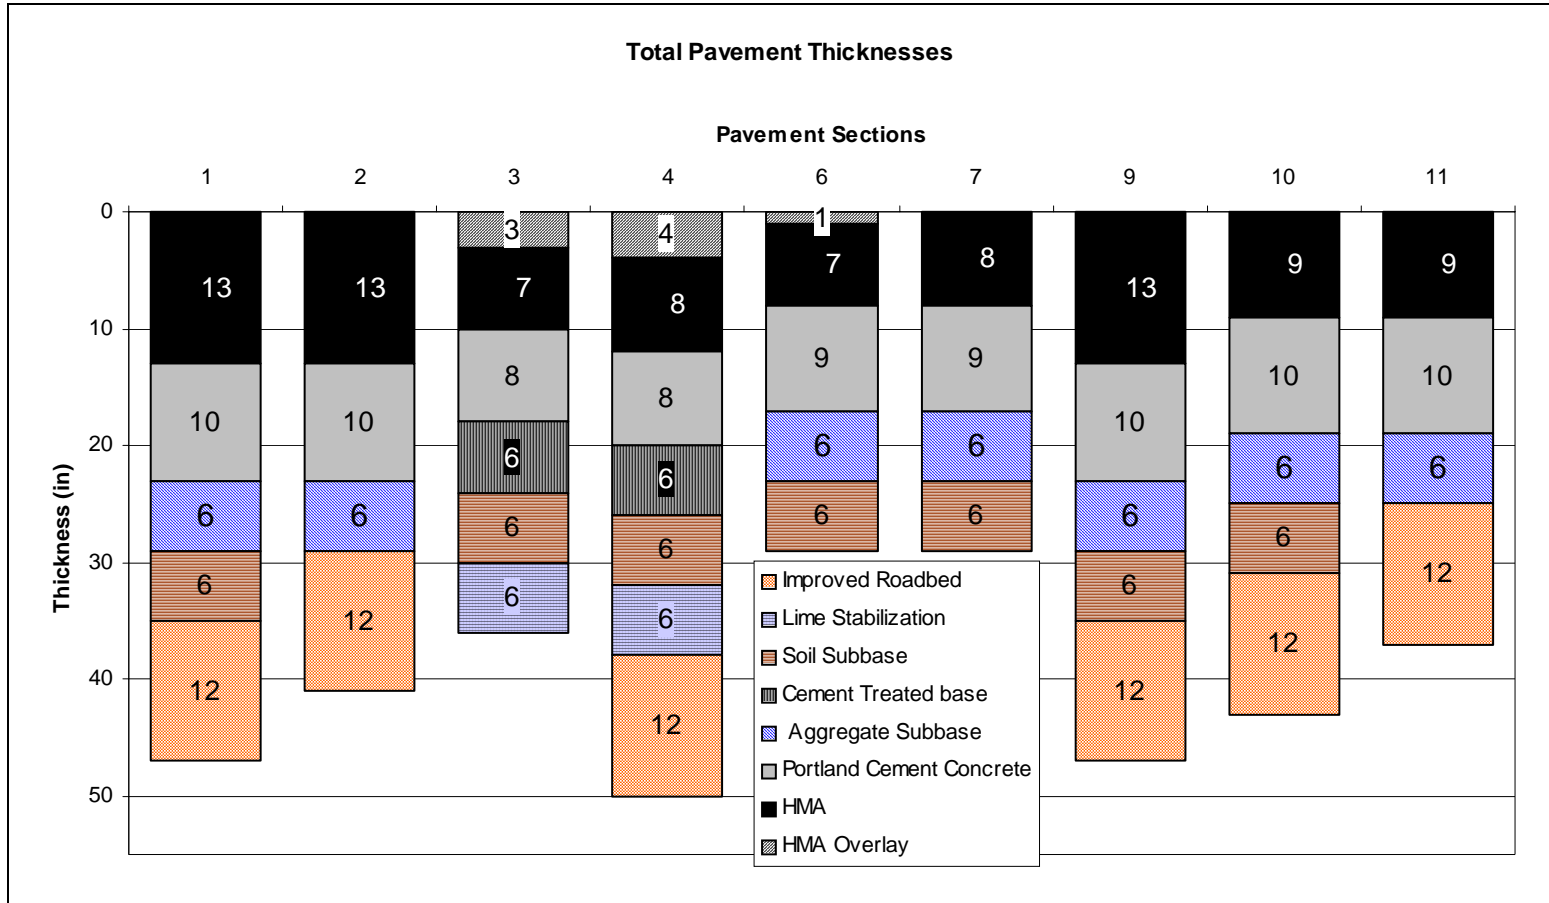
Figure 3.2 Total Pavement Thicknesses of Rubblized Sections.

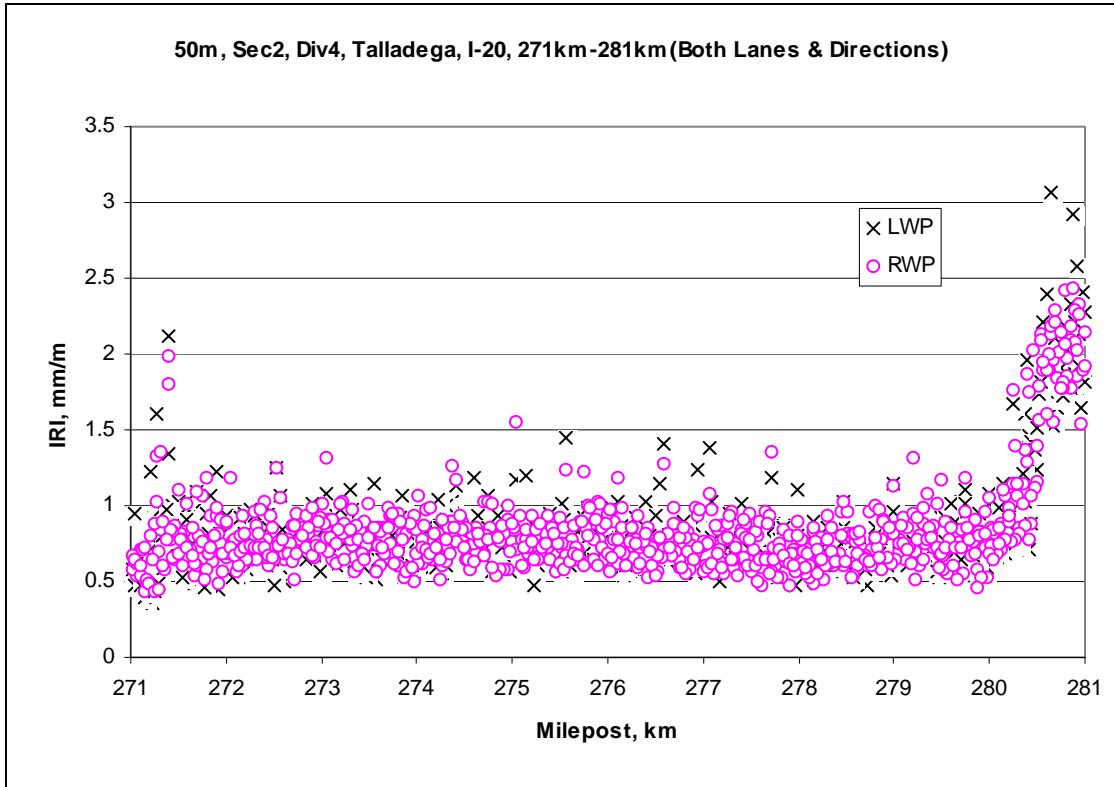
Figure 4.1 2001 IRI vs. Distance for Section 2.

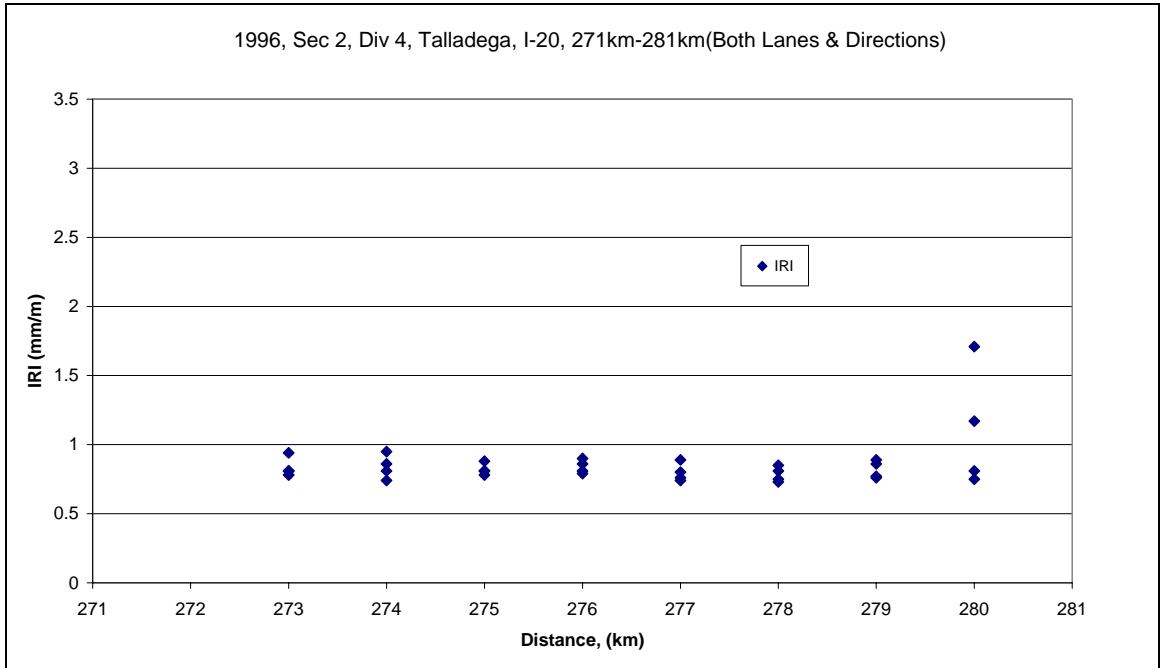
Figure 4.2 1996 IRI vs. Distance for Section 2.

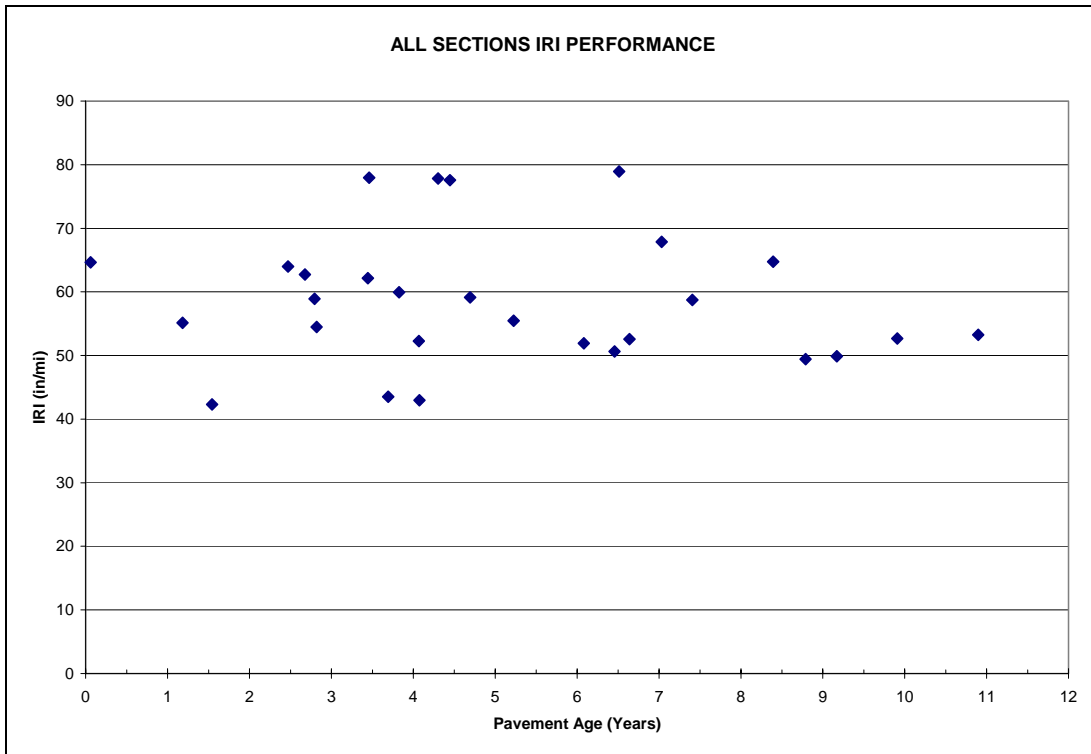
Figure 4.3 IRI vs. Pavement Age.

Having discussed the amount of data and types of data available for analysis, the next step was to organize the information in a way to allow the comparison of each rubblized section. To begin the comparison of the rubblized pavement sections, the distresses obtained from ALDOT that were discussed earlier were plotted against the age of the section (Figure 4.3). The format used above proved to be effective in quickly determining the overall performance of the rubblized sections.

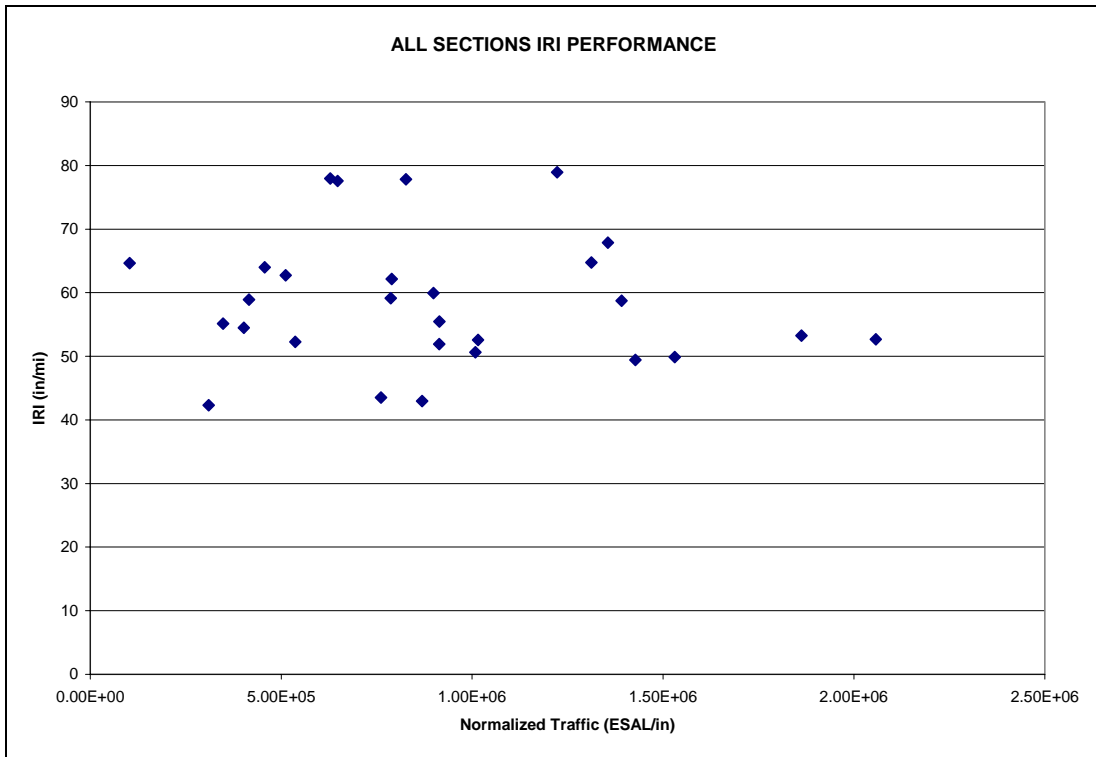
Figure 4.5 IRI vs. Normalized Traffic.

The above-mentioned methods of comparing the rubblized pavements were very helpful to understand the effects of traffic on rubblized pavements, with similar site conditions and construction specifications. However, comparing the distress directly to ESALs does not take in consideration the different thicknesses of the HMAC overlays. To account for this variation in overlay thickness the cumulative ESALs were divided by the pavement thickness to yield ESALs per inch (Figure 4.5).

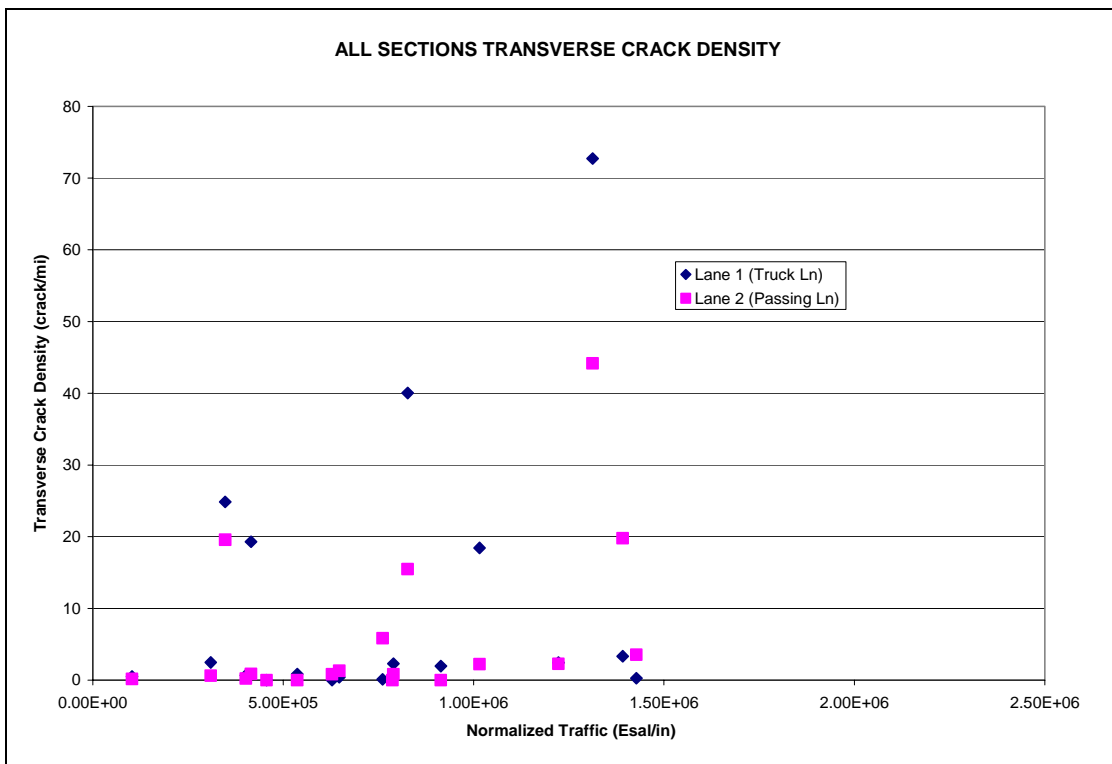
Figure 5.1 Transverse Crack Densities vs. Normalized Traffic.

The data from all of the sections were combined and analyzed with no distinction between the individual rubblized sections. The distresses were plotted for the combined data to better understand how the rubblized pavements were performing in general (See Figures 5.1 – 5.5). The first distress that was evaluated against the three standards is the transverse crack density presented in Figure 5.1.

When studying Figure 5.1, it is important to note that lane one has the highest levels of transverse crack density. This observation is logical because the heaviest vehicles tend to travel in lane one or what is commonly referred to as the truck lane. Another important observation is the magnitude of the data also seems to increase as the pavement age increases.

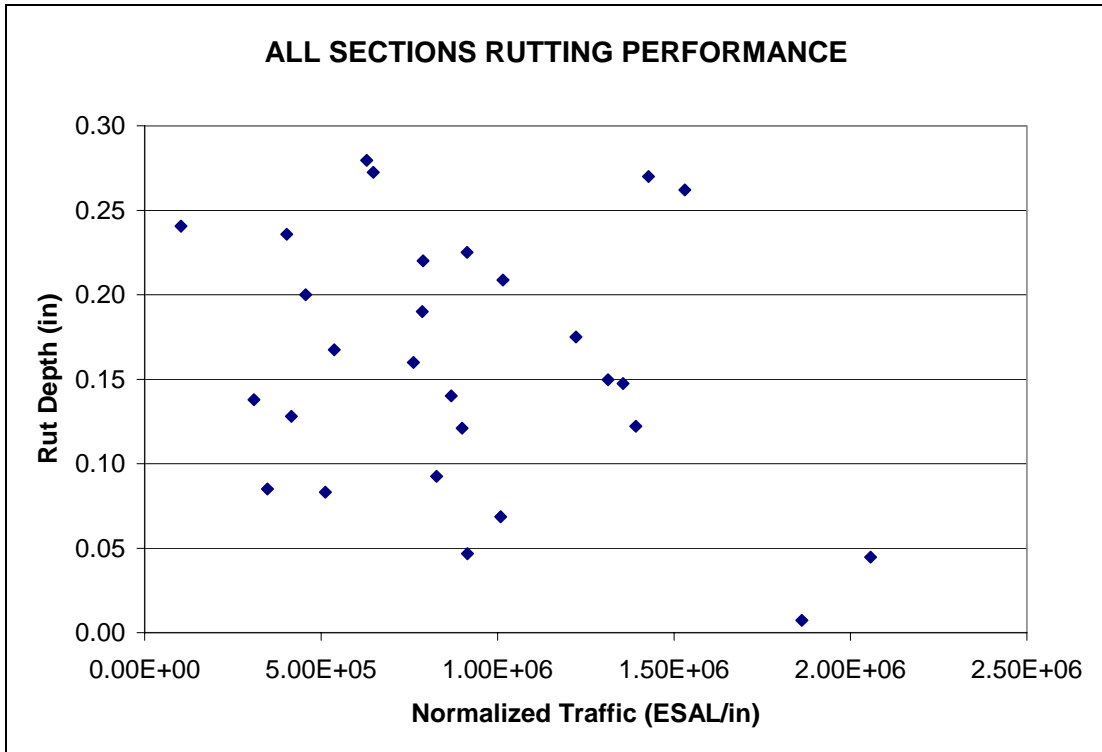
Figure 5.3 Rut Depths vs. Normalized Traffic.

In Figure 5.3, the average rutting values were plotted against the normalized traffic of the pavement section. There appeared to be no recognizable pattern to the distribution of the rutting values. It is important to note that none of the rutting values exceed three-tenths of an inch, and all sections combined have an average rut value of 0.16 of an inch. Also noted is that the 0.16 of an inch, at an average pavement age of five years, is well below the 0.75 of an inch value established by AASHTO, 0.375 inch for a three year old pavement section in Oregon and Washington, and finally 0.25 of an inch in Wisconsin for a five year old pavement. This comparison suggests that the rubblized pavement sections are rutting at a minimum level. This minimum amount of rutting could possibly be contributed to the seating of the rubblized PCC pavement or densification of the mix under traffic. The fact that there is not an excessive amount of

rutting present in any of the rubblized sections could be attributed to the significant structural cross sections. In other words, one would not expect to see deep structural rutting due to failure of the subgrade.

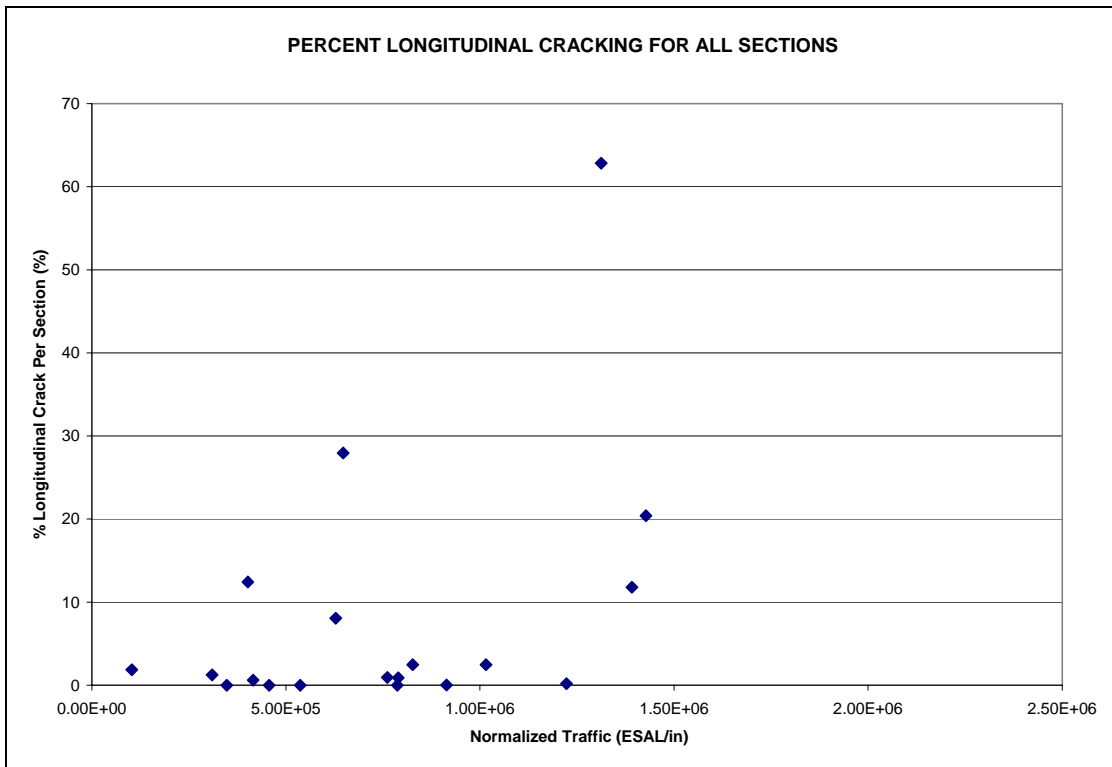
Figure 5.4 Percent Longitudinal Cracks vs. Normalized Traffic.

The next performance graphs that were evaluated were the percent longitudinal cracking in the rubblized pavement sections. These data are provided in Figure 5.4. At first glance, the data present a trend that forms a logical pattern. This trend shows that as the pavement age increases, the magnitudes of the distress also increase.

established by proposed AASHTO 2002 Design Guide. When compared to the thresholds established by Oregon and Washington, the eight percent average exceeds the 5.5 percent threshold. This comparison seems to suggest that the Alabama rubblized sections have surpassed the Oregon and Washington thresholds.

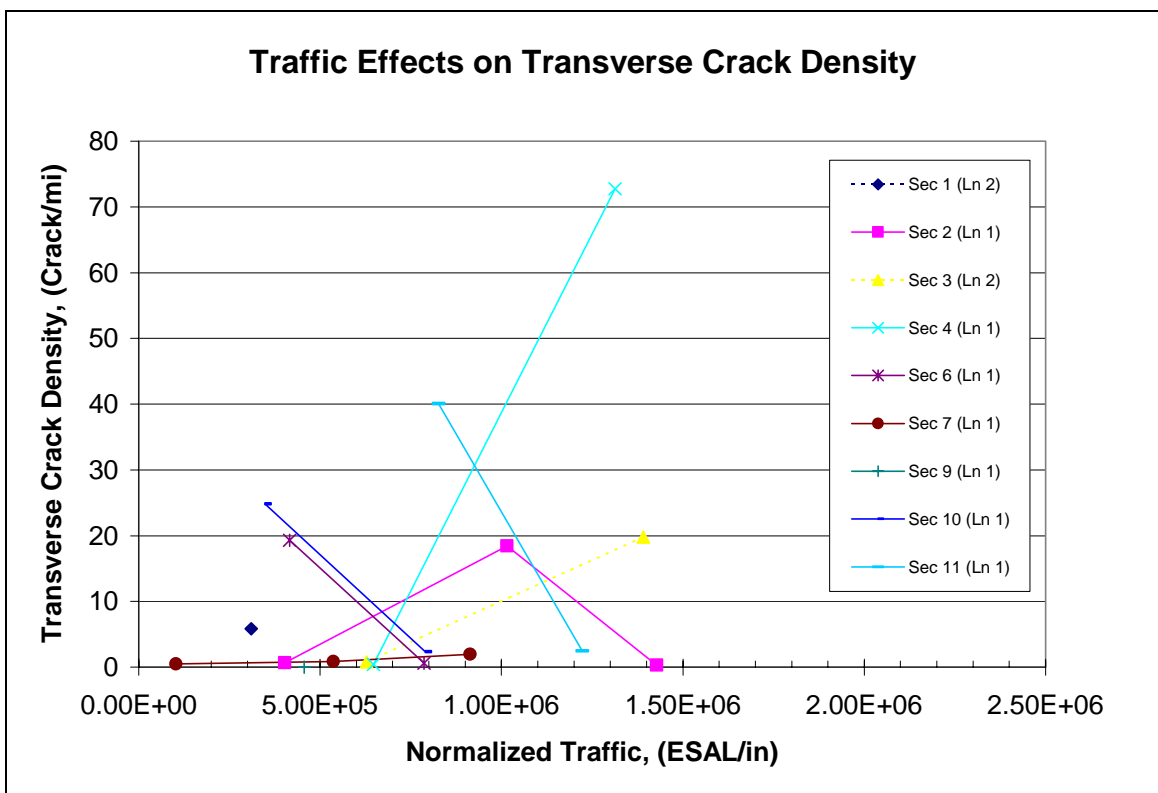
Figure 5.6 Transverse Crack Density vs. Normalized Traffic.

Upon analysis of the percent of transverse crack density graph, there were two main points to be noted. The first is that section four has the highest levels of distress. The possible reason for this high level will be stated later. The second point is that in most cases lane one exhibited the highest levels of distress. The fact that the higher levels of distresses are present in lane one seems logical because the higher volume of heavy vehicles travel in this lane.

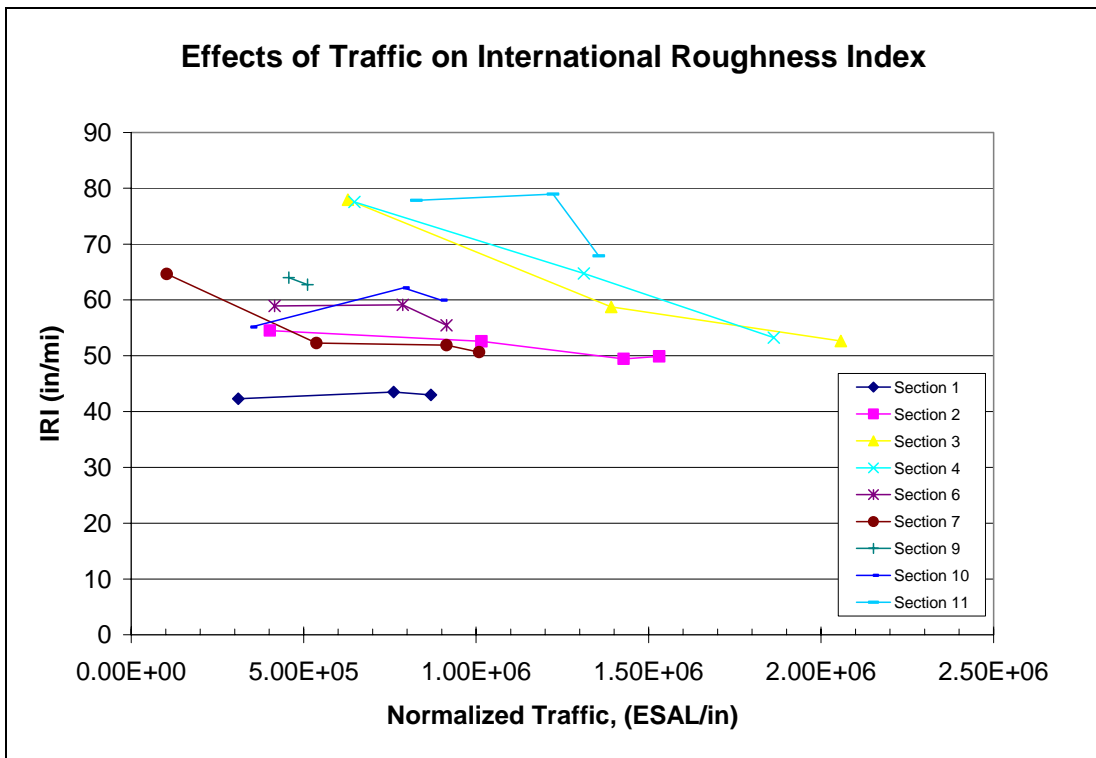
Figure 5.7 IRI vs. Normalized Traffic.

In Figure 5.7 the IRI distresses are evaluated for unique trends. There are two major points to recognize when analyzing the IRI graphs. The first is that in most of the sections the values of the given distress decreased initially. After the HMA overlay has been constructed, a certain degree of compaction under vehicular traffic evidently takes place. This reduction in IRI values could possibly be a direct result of the rubblized

pavement seating from increased traffic loading. This trend is also shown in Figure 5.10 where the distress data from Highway 280 are presented. The second point to be made about Figure 5.7 is that sections three and four, the two CRCP, are among the sections exhibiting the highest levels IRI distress.

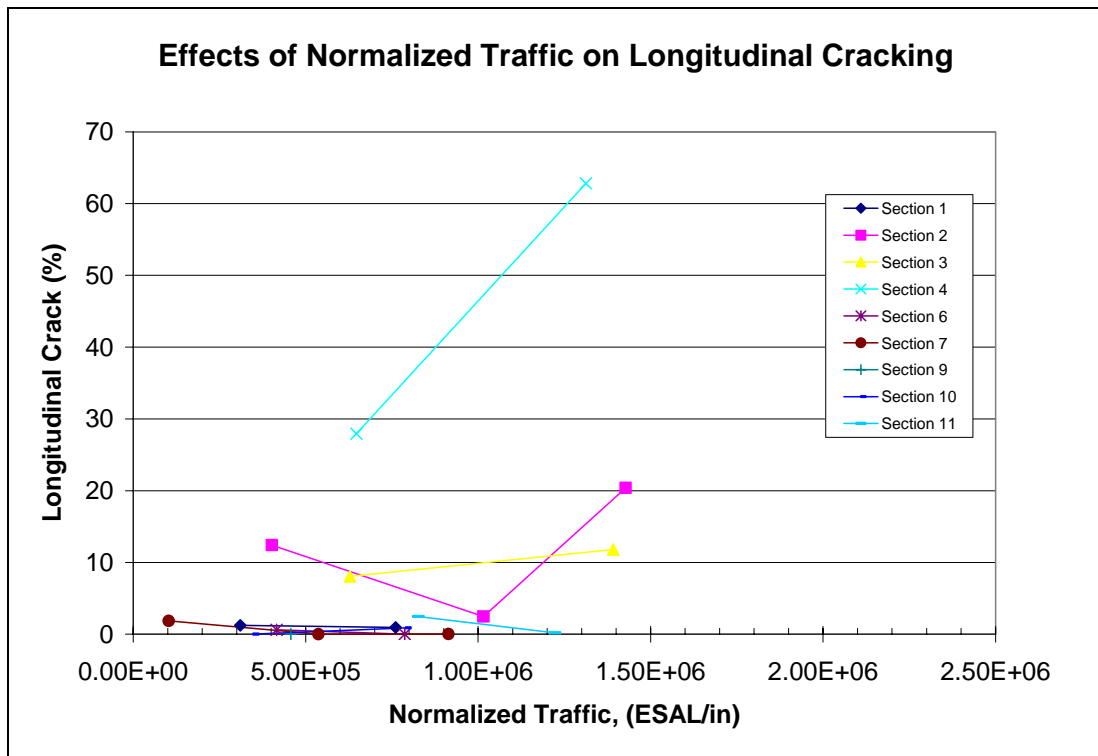
Figure 5.8 Percent Longitudinal Cracking vs. Normalized Traffic.

Next, percent longitudinal cracking and average alligator cracking were explored by pavement section in Figures 5.8 and 5.9. These two distresses will be discussed at the same time because they both have similar trends and are consistent throughout the data. Both distresses are present in low amounts throughout the Alabama rubblized pavements. As noted above, sections three and four are again among the sections that have the largest amounts of distresses present. Reviewing the distresses on section-by-section bases,

provided an important perspective into the performance of the rubblized sections. Observing that sections three and four consistently had the highest levels of distress, raises questions about the possible causes for their elevated levels.

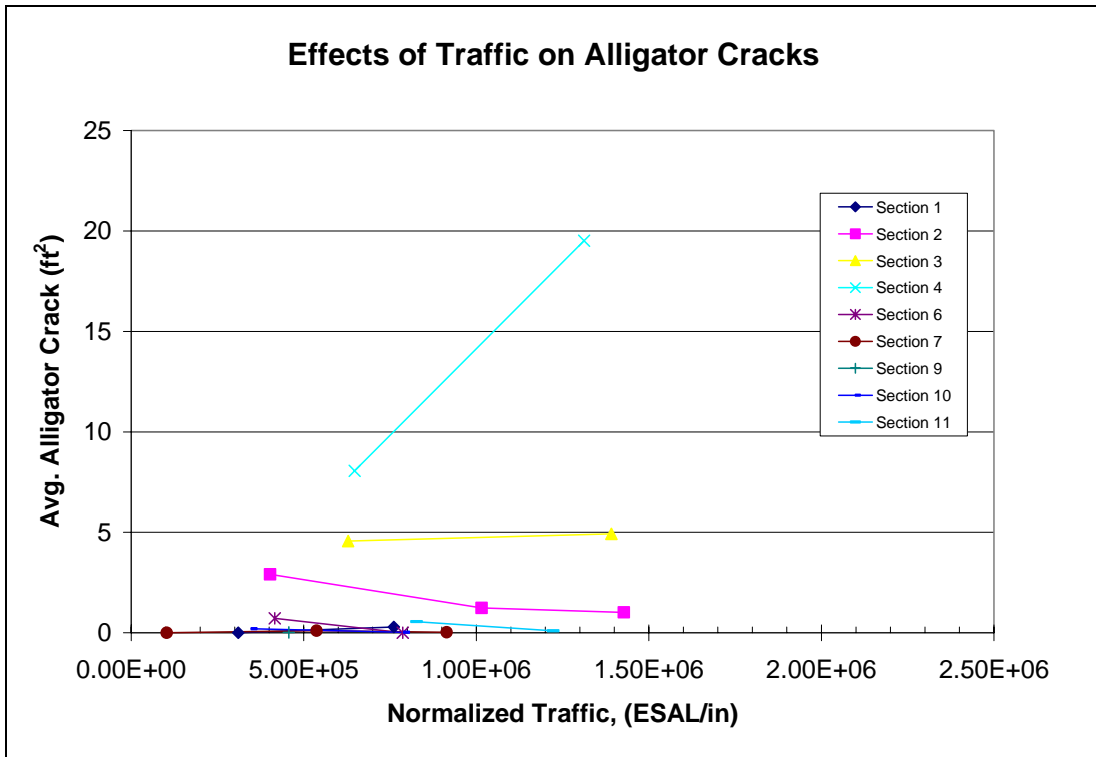
Figure 5.9 Average Alligator Cracking vs. Normalized Traffic.

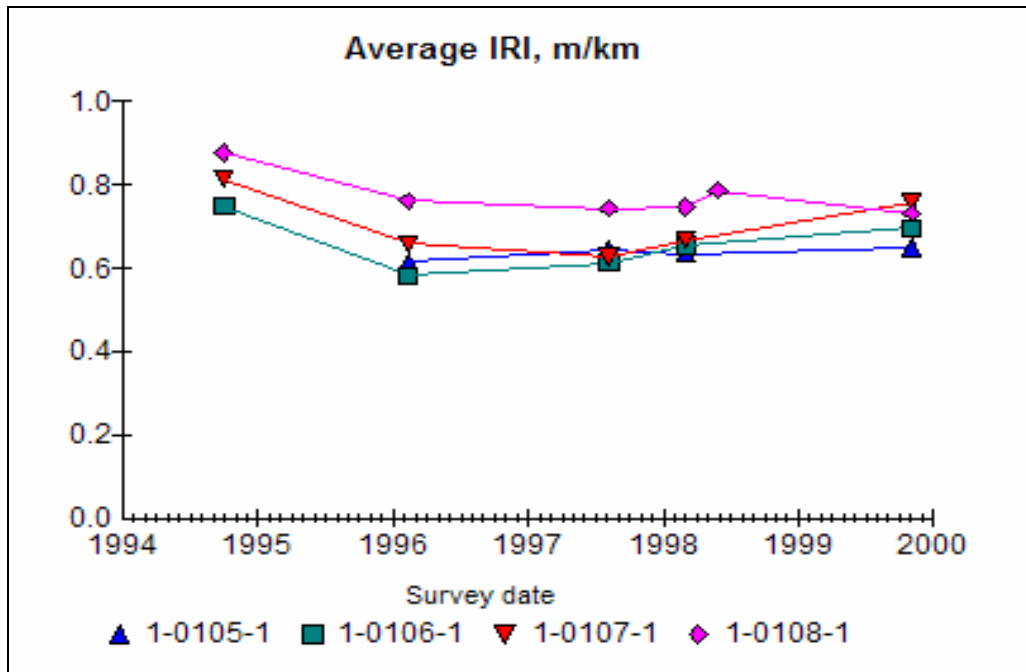
Figure 5.10 IRI vs. Survey Date for Highway 280.

In Chapter 4, U.S. Highway 280 was mentioned as a tool that would serve as a comparison for the performance of the rubblized sections. Figure 5.10 is a graph from

LTPP database. This was included to illustrate the decrease in IRI levels. This decrease was also observed in the IRI levels in the above-mentioned rubblized pavements. Table 5.3 is shown below Figure 5.10 for a direct comparison of the two different measurement systems.
